Resilient Connecticut 2.0 Phase II

Regional Adaptation/Resilience Opportunity Areas

Name: Main Street / River Road

Location: Cromwell

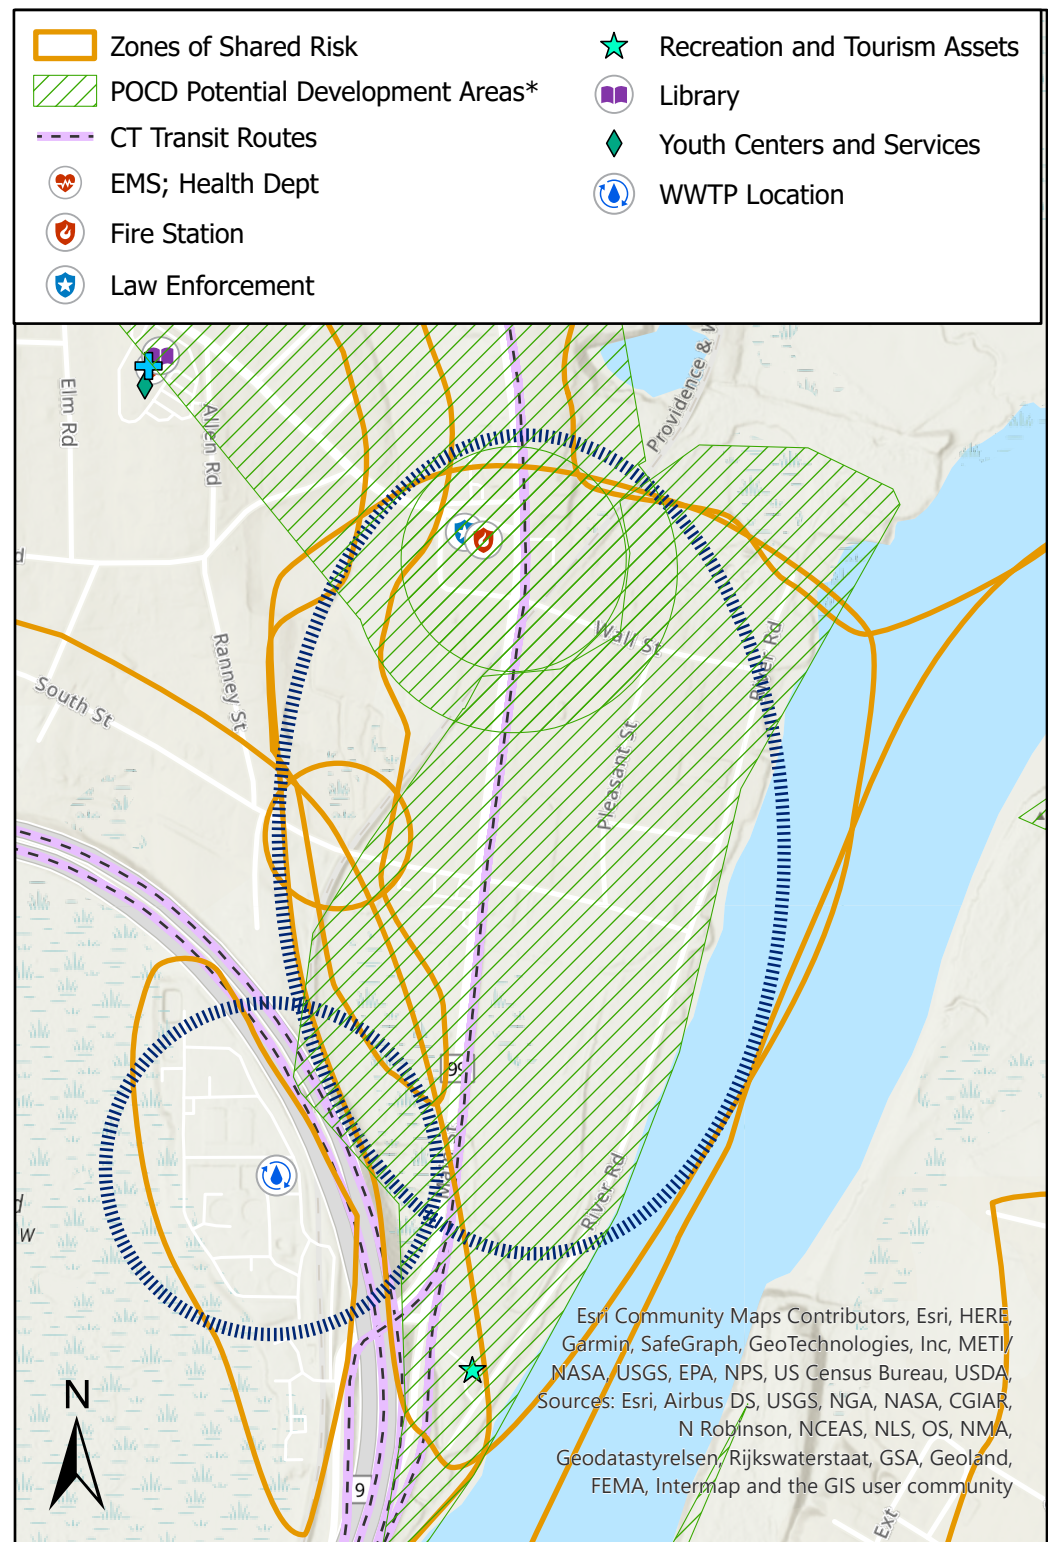
This section of Cromwell contains many residential properties within the 100-year flood zone of the Connecticut River, overlapping with an EJ census block group. In addition to riverine flood risk, previous rainstorms have led to a culvert that conveys Cromwell Creek overtopping West Street and flooding the ground floor of the Cromwell Police Department. Prior analysis performed by the town's consultant has determined that this culvert can only convey the 25-year storm, not the 100-year storm. This ROAR is also in close proximity to the Mattabasset WPCA ROAR.

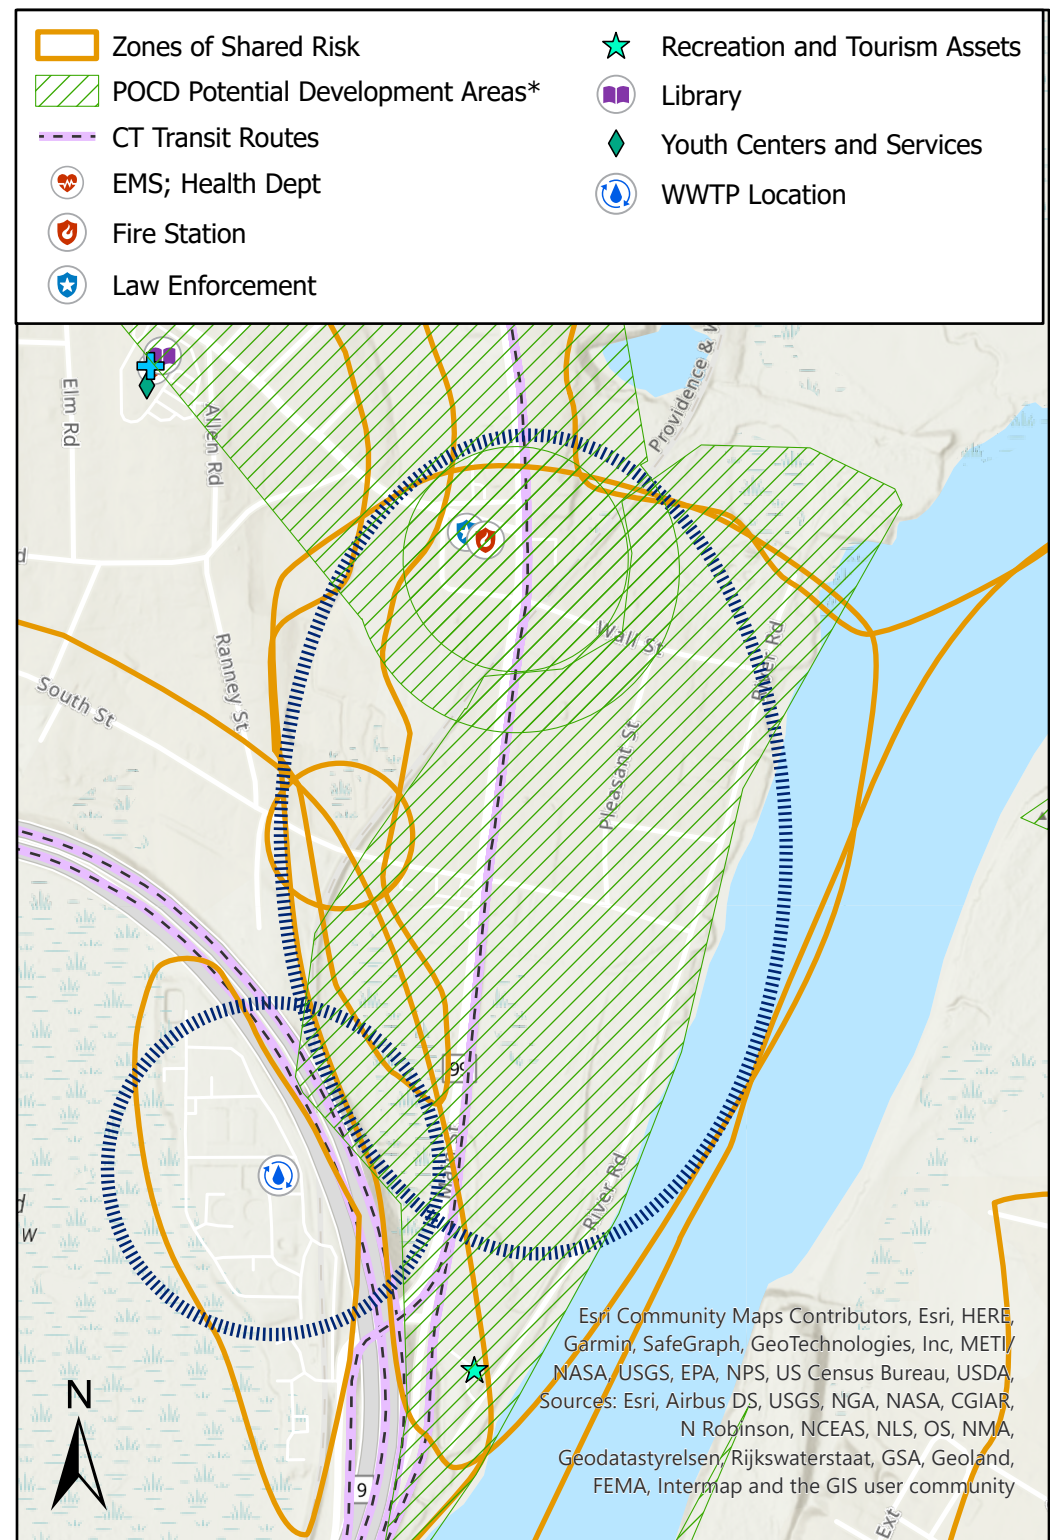
Esta sección de Cromwell contiene muchas propiedades residenciales dentro de la zona de inundación de 100 años del río Connecticut, que se superponen con un grupo de bloques censales de EJ. Además del riesgo de inundaciones fluviales, las tormentas anteriores han provocado que una alcantarilla que transporta el arroyo Cromwell desborde West Street e inunde la planta baja del Departamento de Policía de Cromwell. El análisis previo realizado por el consultor de la ciudad ha determinado que este culto sólo puede transmitir la tormenta de 25 años, no la tormenta de 100 años. Este ROAR también está muy cerca del ROAR de Mattabassett WPCA.
